FPE Panels – Hazard or Hype?

by Douglas Hansen

This article focuses on the controversy over inspecting and reporting Federal Pacific panels. It has been published in the magazine for the California Real Estate Inspection Association and in other technical journals.

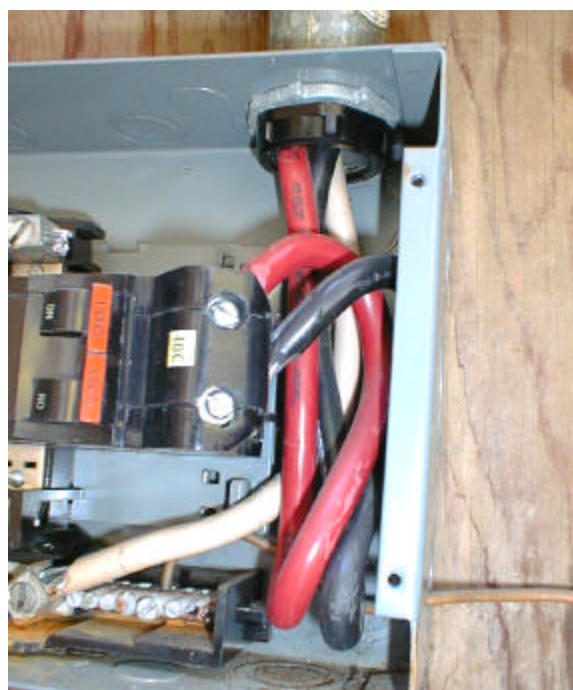
Several of the problems found with FPE panels are found in other brands of equipment of the same age. There is less gutter space in the panel than we find in modern equipment. The result is crowding of the wires in the panels. It is sometimes impossible to see all of the terminals in an FPE panel. The space for bending wires is also less than required in modern panels. The rules that proscribe minimum wire bending space are found in the National Electrical Code (NEC) in section 312.6 in the 2002 edition. Over the years, the required minimum space has increased, with the most significant changes in the 1981 NEC, near the very end of the days when FPE panels were made. FPE manufactured some panels with less clearance than the minimum code rules by installing the lugs at an angle, so the conductor was already parallel to the wall opposite the breaker terminal (figure 1). However, the bends shown in figure 1 defeat the purpose of the angled lugs, and the wire is bent too sharply.

Figure 1 – Insufficient wire bending space

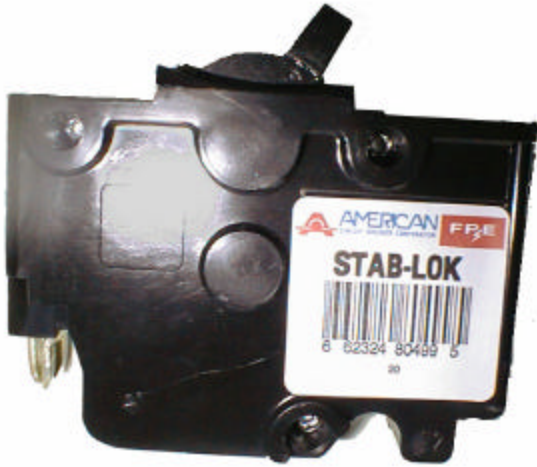
If the breakers themselves are the problem, should homeowners consider replacing the breakers and keeping the panel? At various times over the last 2 decades, different manufacturers have made after-market products designed to fit FPE panels. In some cases, these breakers have been made in Canada, Mexico, or China. Salvaged old FPE breakers are also available from specialty dealers. The breakers sold under the “American” brand (figure 10) are no longer UL listed, though they are listed by ETL, another nationally recognized testing laboratory. In all cases, replacement breakers are very expensive, with a single-pole 15 amp breaker costing as much as \$50. If one wanted to replace all the breakers in a panel, they could spend a great deal more than it would cost to replace the panel with modern listed equipment.

Figure 10 – Replacement Stablok breaker
